> UM-3731-98 1998 Chevrolet Camaro

# In-depth Vehicle Occupant Report

The University
of Michigan
Transportation
Research Institute

Case Vehicle (A): 1998 Chevrolet Type: Camaro, 2-door coupe

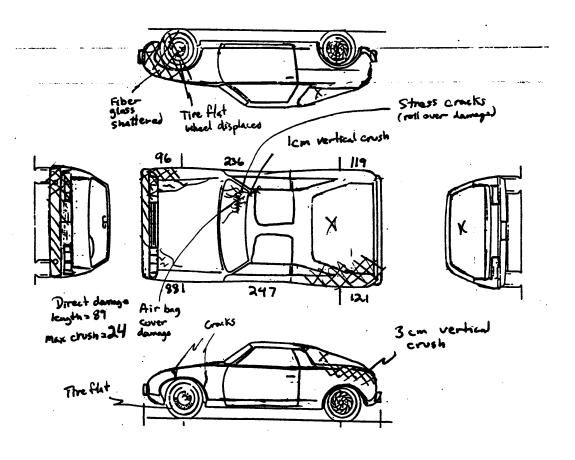
# **VEHICLE DAMAGE**

(Slides 10, 11, 12, 13, 14) Damage to case vehicle (A) was moderate. Direct-damage length from the frontal impact was 89 cm and began at the right-front bumper corner. Maximum crush was 24 cm and occurred at the right-front bumper corner. The front bumper, right headlight assembly, radiator, and both fenders were damaged. The right-front wheel was displaced 31-cm rearward, and this damage probably caused the airbag to deploy. The hood was damaged, and the hood latch released. Both of the hood hinges were damaged, the rear edge of the hood was elevated, but did not contact the windshield.

Direct Damage Length (DDL)

$\underbrace{0}_{35} \underbrace{8}_{37} \operatorname{cn}$

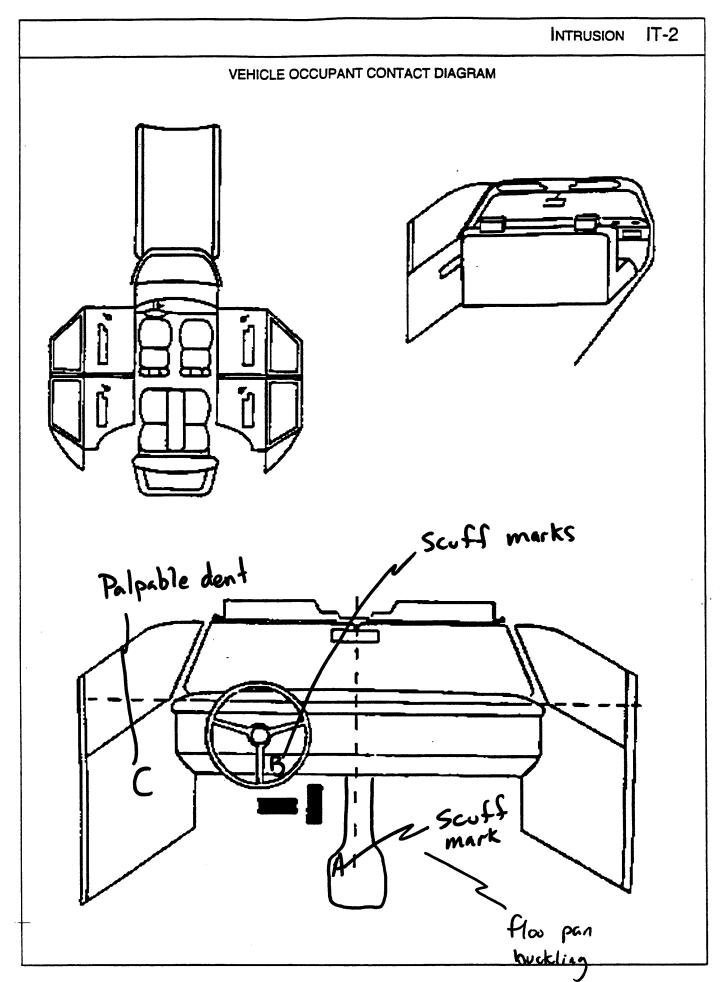
# INTRUSION IT-3

INTRU	JSIOI	N IT-1
				(All Meas	urements Are in	Centimet	ers)		D:
Location of Intrusion	Intruded Comp	ponent	Comparise Value	on _	Intruded Value	=	Intrusion		Dominant Crush Direction
/3	Floor par		31	-	-21	=	10		υp
	(buckled)			_	_	=			
				_	-	=		T	
****				-	_	=			
				_	-	=			
					_	=			
				_	-	8			
				-	-	=			
					<del>-</del>	=			
				_	-	=			
					_	=			<u>.</u>
				_	-	=			
					-	=			
			· · · · · · · · · · · · · · · · · · ·	-	-	=			
-				_	-	=			
					-	=			
		occi	UPANT CO	ONTAC	T WORKSHE	ET			
Contact	Component N	upant o. if F own if	Body Region Known		Supporting	Physical	l Evidence		Confidence Level of Contact Point
Α									
В									
С									
D									
E							•		
F									
G									
Н									
ı				<del></del>					
J

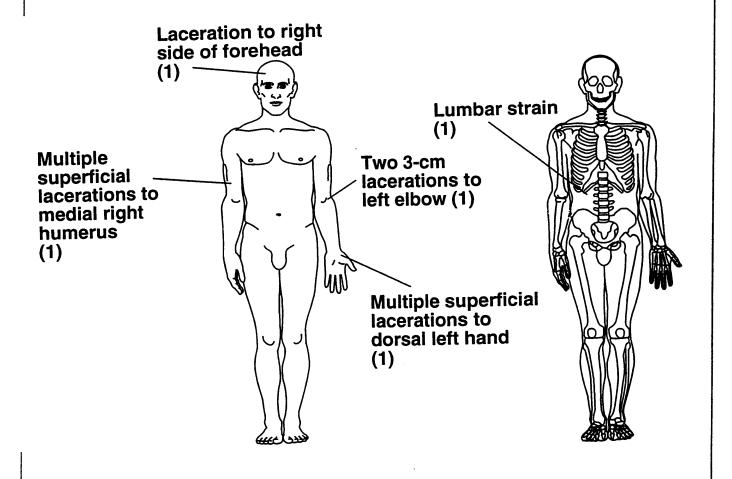
# INDICATE LOCATION OF INJURIES.

(Slides 30, 31) The 18-year-old male driver was reportedly wearing the available three-point belt and the airbag deployed. During the frontal impact, he moved forward and to the right relative to the vehicle and into the deploying airbag. (Slides 32, 33, 34, 35) He sustained a laceration over the right side of his forehead, possibly from contact with the roof/T-top. He sustained two 3-cm lacerations to the left elbow, and multiple superficial lacerations to the dorsal left hand and medial right humerus, probably from flying glass. He also sustained a lumbar strain due to impact forces.
